# ACT: Automated CPS Testing for Open-Source Robotic Platforms

A Case Study with  
Lingua Franca & LF Embedded Systems Labs

The 7th ACM/IEEE International Conference on  
Automation of Software Test (AST 2026)

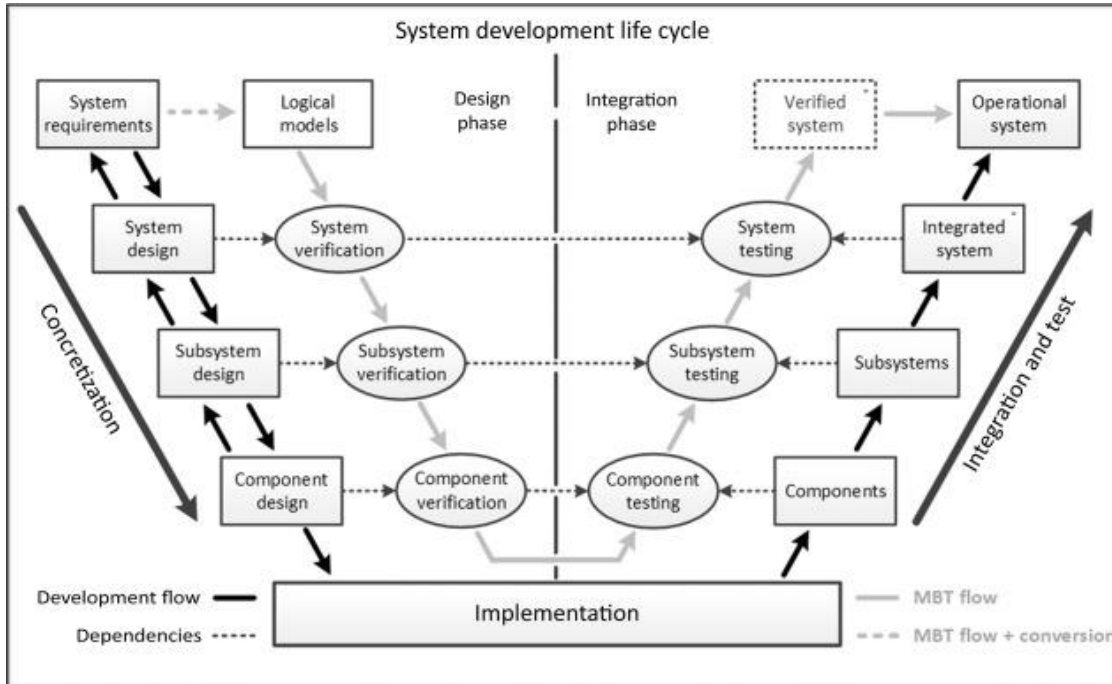
- The System/Software Development Life Cycle (SDLC) includes many phases of testing for each verify a stage of the development before moving forward.
- Detecting bugs during each stage of testing has increasing difficulty and cost as the system nears the operational stage.

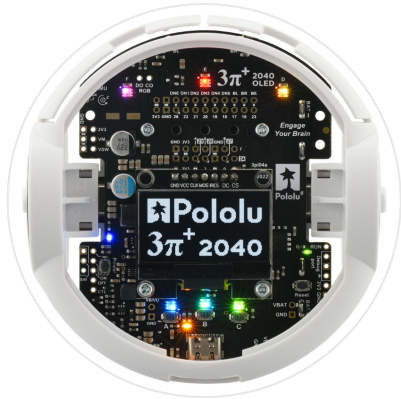
- **LED**

LED serves as a representation of status indicators on robots or CPS.

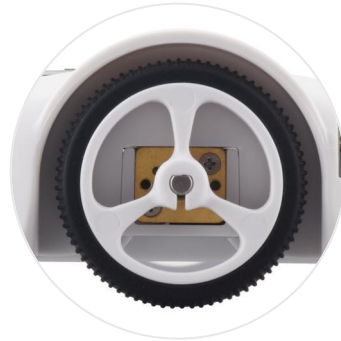
- **Motors**

Motors are actuators which allow motion on many robots.

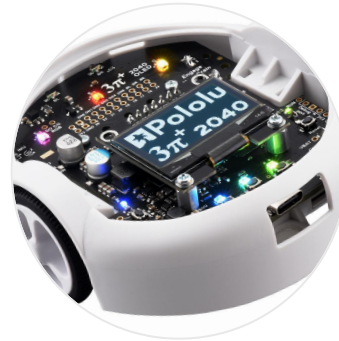
- **IMU and Display**

IMU is used for navigation since there are no cameras on this robot.

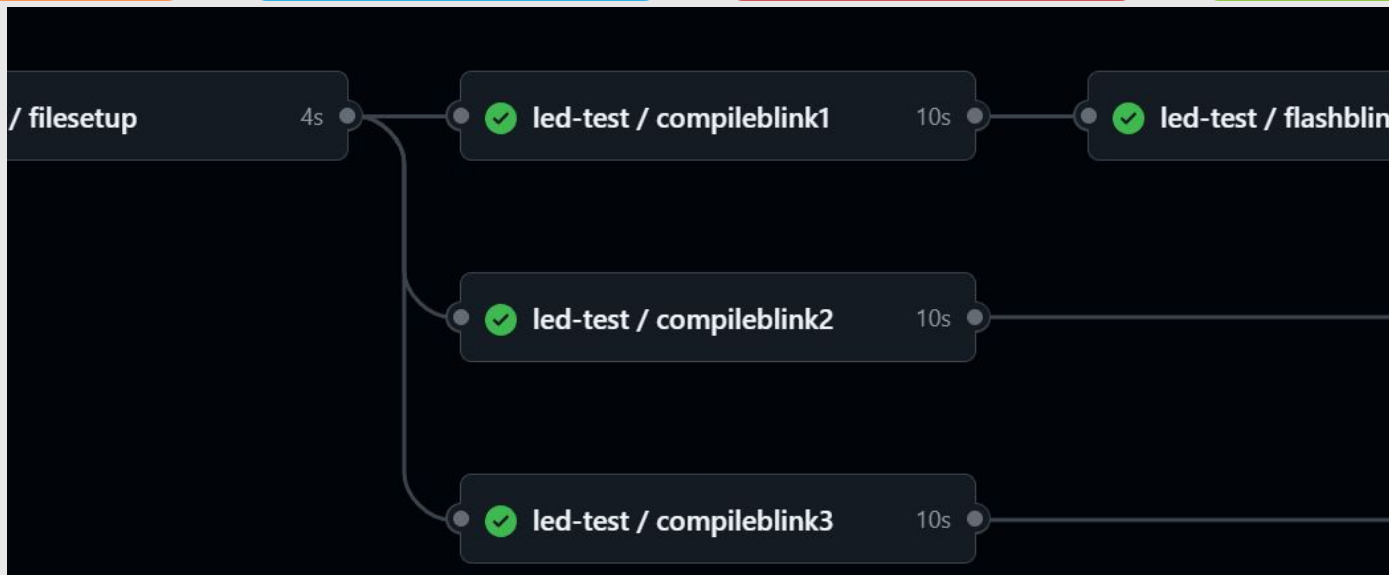
# GitHub Actions Flow

- The actions are triggered using conditions specified in the yml file in the workflow directory of the respective repository.
- The flow of the GitHub actions for testing can be thought of as four categories.
